Channel Planform Dynamics along Distributary Channels: Case Study of the River Nun a Major Distributary of the River Niger

Original Research Article

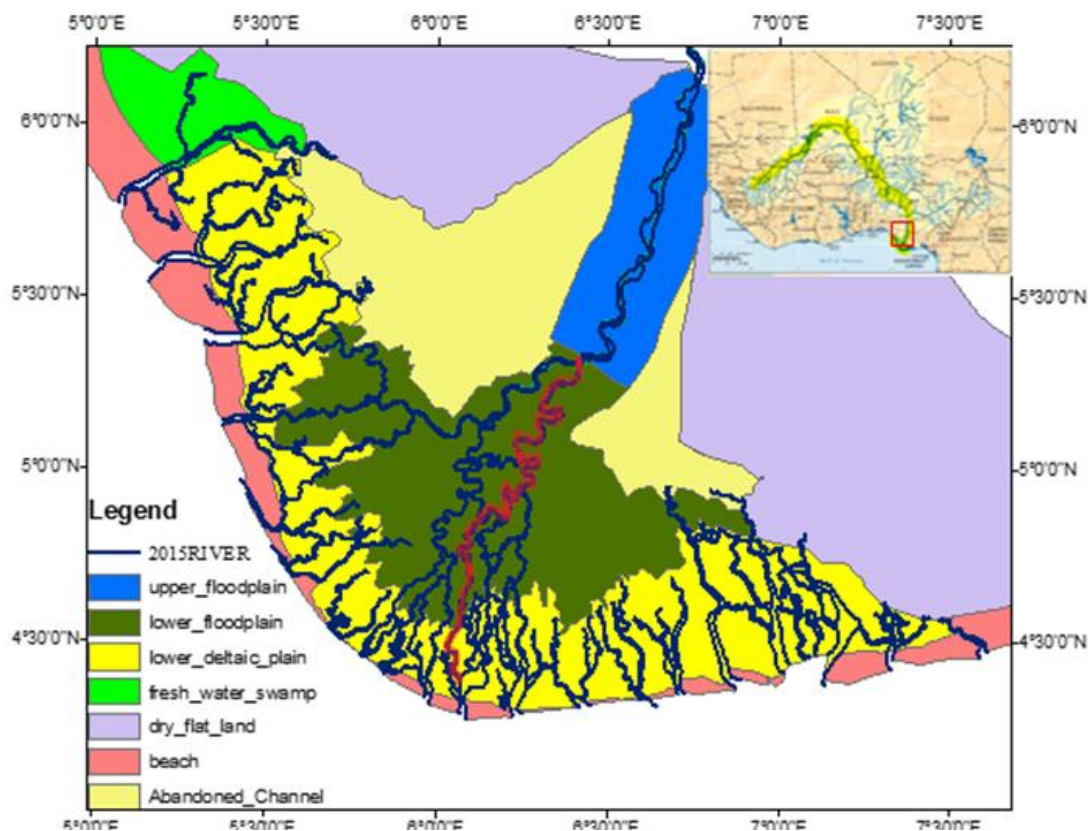
Fig. 1. Geologic map of Niger Delta denoting study location and major sedimentary environments as defined by the fluvial, tidal and wave-related processes (River Nun channel highlighted in red)

The River Nun (Fig. 1) lies within the southern part of Nigeria and is considered as a distributary of the River Niger. The Nun begins after the bifurcation of the River Niger into 2 at about 32 km downstream from Aboh in the Niger Delta. The Nun flows through sparsely settled zones of freshwater and mangrove swamps and coastal sand ridges before completing its about 180-km south-southwesterly course to the Gulf of Guinea, through a wide inlet of the Atlantic

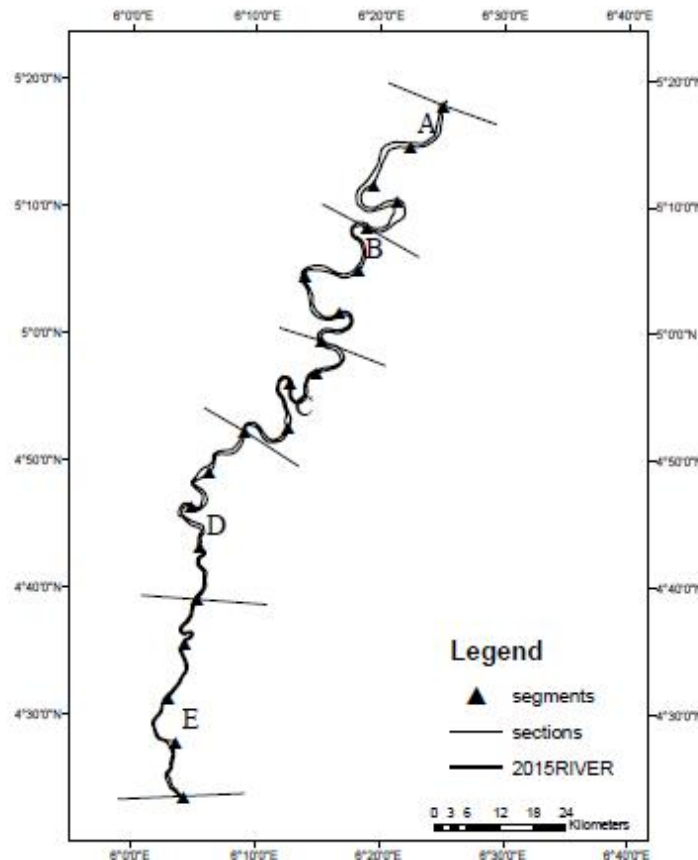
Fig. 2. Channel course of the River Nun denoting transverse sections and segments

In the GIS software, continuous polygons were created to represent the stream channel in each year using the image (map) data. These polygons were digitized on the screen at a scale of 1:30000, and methodological consistency was maintained by having a single operator perform all polygon delineations. Using these techniques, a georeferenced polygon coverage of the active channel was created for each image (Fig. 2).

The digitized river channels of 1985 were divided into five equal segments(A–E) of 38 km each (Fig. 2) for River Nun. The starting point was designated as section a-a and the channel reach between section a-a and section b-b was designated as segment A, and so on. A combined map was prepared by superimposing the digitized river channels of all years to assess changes during different time periods. Changes

The digitized river Nun channel of 1985, 1995, 2005 and 2015 was divided into five equal segments (A–E) of 32 km each. The starting point was designated as section a-a and the channel reach between section a-a and section b-b was designated as segment A and so on. Each segment showed a variation of change
