Tibial Blowout”- A Complication of Arthroscopic Anterior Cruciate Ligament Reconstruction

Case Study

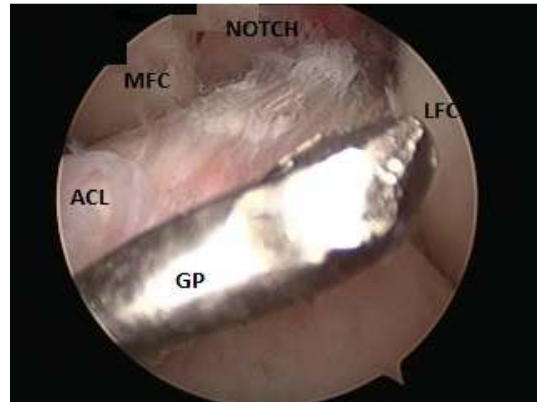
Fig. 1. Arthroscopic view of anterior placement of the guide pin in the tibial footprint. The guide pin can obliquely enter the native tibial footprint if due care is not taken by the surgeon while drilling the guide wire in tibia. This increases chances of tibial blow out secondary to anterior tunnel positioning

MFC – Medial Femoral Condyle; LFC- Lateral Femoral Condyle; GP- Guide Pin; ACL- Anterior Cruciate Ligament

The graft was measured 8 mm in diameter and hence 8 mm x 30 mm femoral tunnel was made using a cannulated reamer over the guide wire. The ACL jig was adjusted to 55 degrees and was placed just lateral to the medial tibial spine. Foot print guide was placed over the foot print of the native tibial ACL attachment. Under arthroscopic guidance, the guide pin was centered in the tibial footprint and was accepted (Fig. 1).

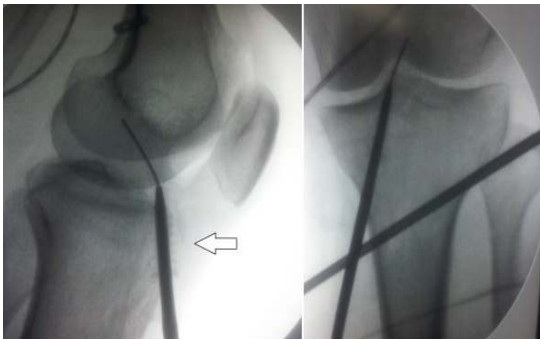
was absence of the usual bony resistance. To assess the same, an intra-operative image intensifier was used. We found that the tibial tunnel was too anteriorly placed and had "blown out" with a flake of anterior tibial bone (Fig. 2).

Fig. 2. Intra- operative image intensifier showing too anteriorly placed tibial tunnel. The tibia had “blown out” with a flake of anterior bone

The options that we had at this stage to manage the problems were: Option 1- Removal of the tibial screw combined with removal of graft and, and redrilling a new tibial tunnel. Option 2- Removal the tibial screw, repeat preparation of the tibial tunnel without removal of the graft and securing the graft in the new tibial tunnel. The removal of the graft (option 1) would require the cutting of the flipped button on the posterolateral femoral cortex. This however required additional opening on the posterolateral aspect and dissection down till the cortical bone. The dissection has to be performed carefully to avoid the potential injury to the neurovascular structures. However retaining the graft and the button and salvaging the situation would mean using option 2 above with the advantage of no additional wound in the posterolateral aspect of the distal thigh and no risk of the potential injury to neurovascular structures and there is no additional cost of the implant (tight rope. Arthrex). However, this is technically demanding.

We retained the tightrope and the graft on the femoral side. We removed the tibial screw; the

AL portal was slightly increased in size. Using an arthroscopic probe, the each strand of the hamstring graft was delivered out through the AL portal. The tibial jig was repositioned in the native tibial footprint and the tibial cortical entry was confirmed under vision. The guide wire was passed. Additional check for the position of wire was performed using intraoperative image intensifier (Fig. 3) in anteroposterior and lateral images. Reaming of tibial tunnel was done for 8 mm and each strand of the quadrupled hamstring was delivered through tibial tunnel by using the arthroscopic probe and the the previously placed Ethibond sutures at the end of hamstring tendons. The graft was secured in the tibial tunnel using bio absorbable screw. The position of the graft was checked arthroscopically and was satisfactory.

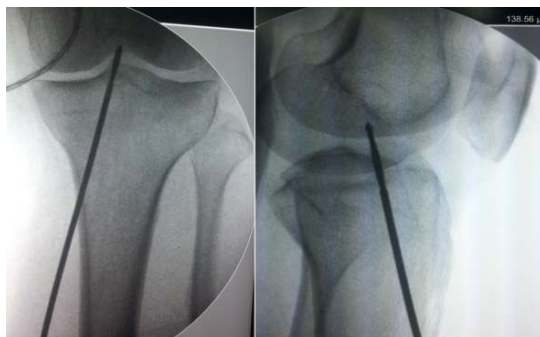
Fig. 3. Intraoperative image intensifier showing the correct position of the guide pin for tibial tunnel preparation, in both anteroposterior and lateral views
