Impact of Solid Waste Dumpsite on Groundwater Quality in the Neighbouring Communities

Original Research Article

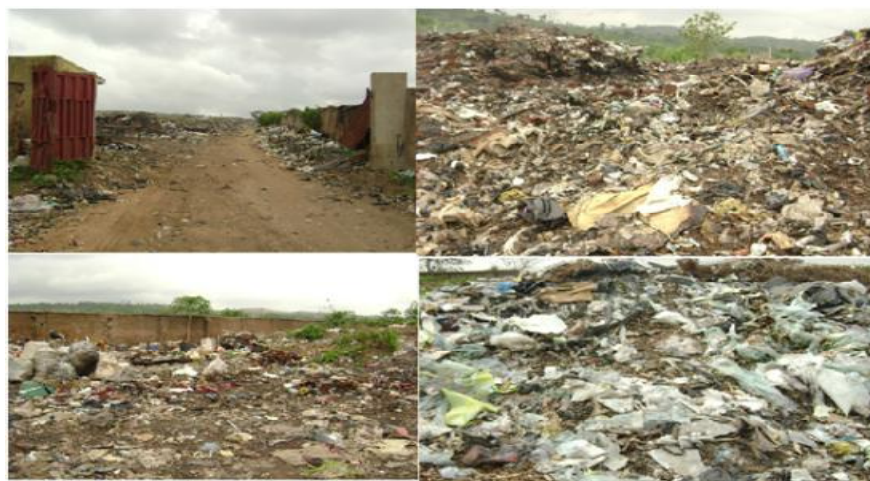
Fig. 2. Indiscriminate dumping of waste within and outside Awotan dumpsite

not significantly helped in controlling odour and houseflies. The dumpsite is not a sanitary landfill site and does not possess all the technical requirements, essentially required for solid waste management. A mixed fleet of heavy transport from different parts of the city bring waste to the dumpsite in an irregular manner (Fig. 2). Un-segregated waste is dumped and it is the rag pickers who sometimes rummage and separate the garbage. They generally collect glass material, plastic and metals and sell the items to the recycling units. Solids waste disposed into the dumpsite comprises of domestic, industrial and agricultural components. The biodegradable components undergo decomposition due to the activities of bacteria and fungi and leaching of contaminants into groundwater. Contaminants from the dumpsite can leach into the groundwater due to rainfall and in humid environments. The location map and solid waste dumping practices are shown in Figs. 1 & 2 respectively.
